2004 USFWS Biological Opinion Reports for the Rocky Flats Environmental Technology Site

**Preble's Mouse Mitigation Monitoring Report for the Water Measurement Flume
Replacement Project at the Rocky Flats Environmental Technology Site
2004 Annual Report
USFWS Biological Opinion # ES/GJ-6-CO-02-F-18**

**Preble's Mouse Mitigation Monitoring Report for the Incinerator Project at the
Rocky Flats Environmental Technology Site
2004 Annual Report
USFWS Letter: ES/CO: BZ Concrete Flow (April 28, 2003)**

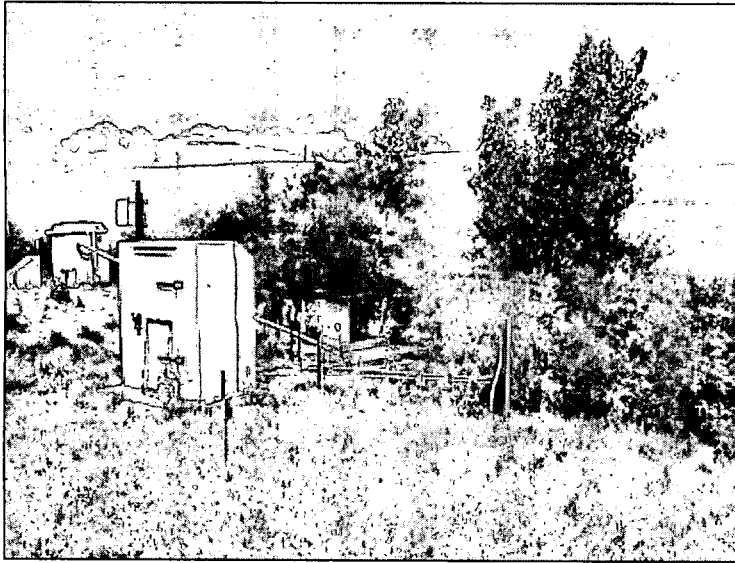
Figure 2. Comparison of pre- and post-construction vegetation conditions at GS03.

Pre-construction Summer 2002

Post-construction Winter 2002/2003

Post-construction Summer 2003

The photographs in Figures 2 through 9 compare the pre-construction with the post-construction conditions at the different locations.

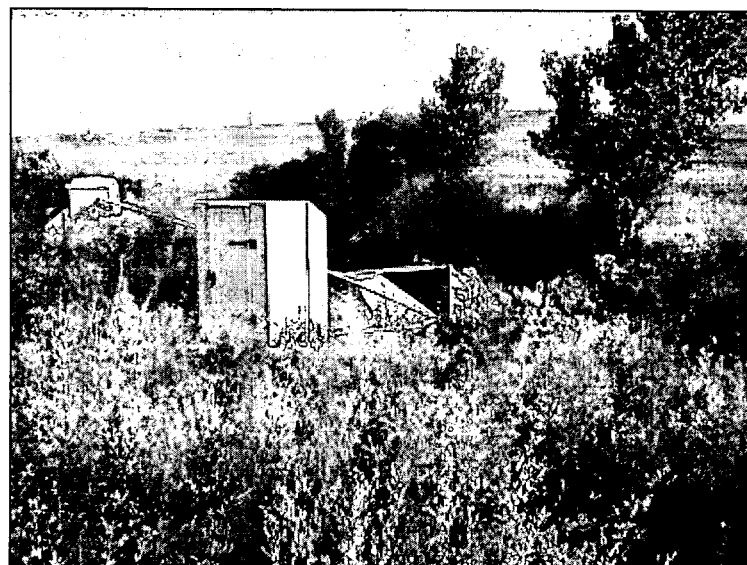
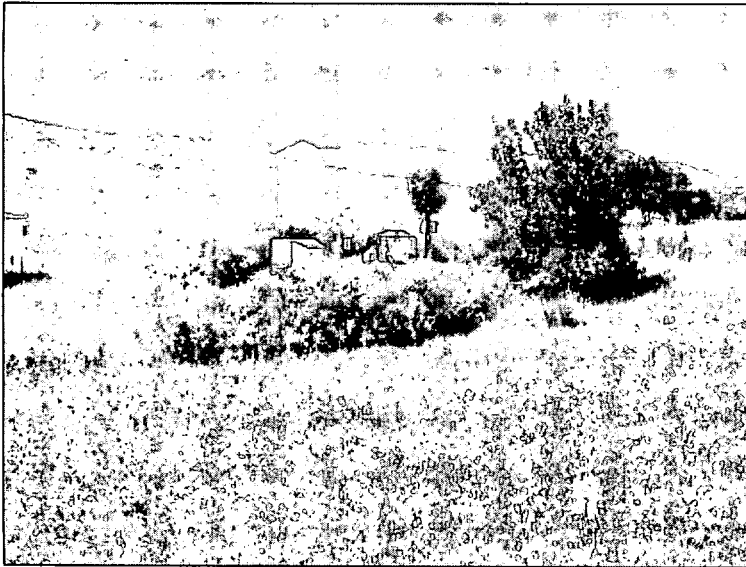
Figure 3. Comparison of pre- and post-construction vegetation conditions at GS03.

Post-construction Summer 2004

Pre-construction Summer 2002

Post-construction Winter 2002/2003

Post-construction Summer 2003

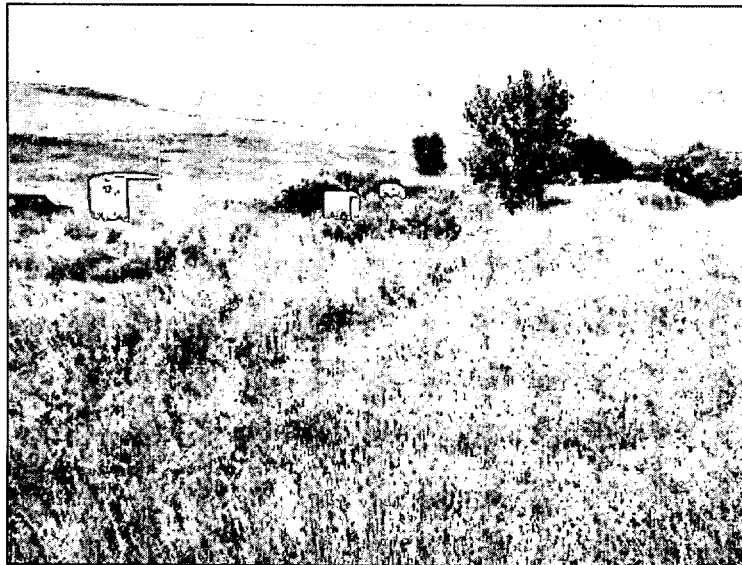
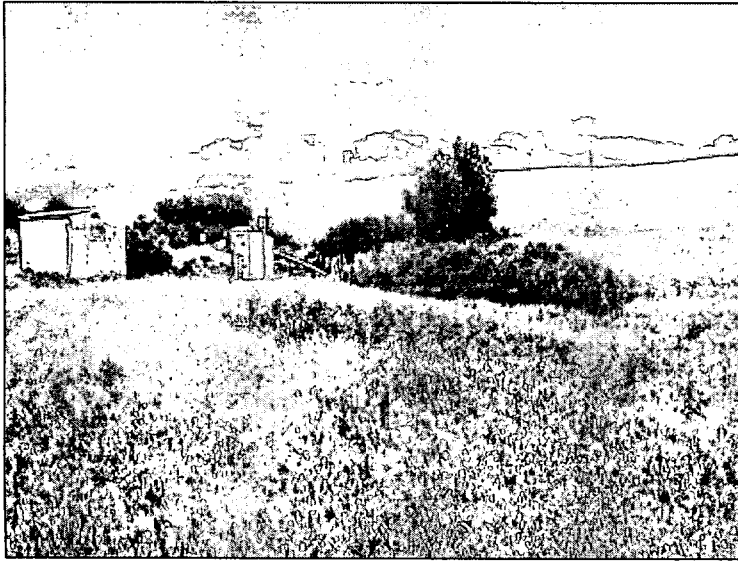
Figure 4. Comparison of pre- and post-construction vegetation conditions at GS03.

Post-construction Summer 2004

Pre-construction Summer 2002

Post-construction Winter 2002/2003

Post-construction Summer 2003

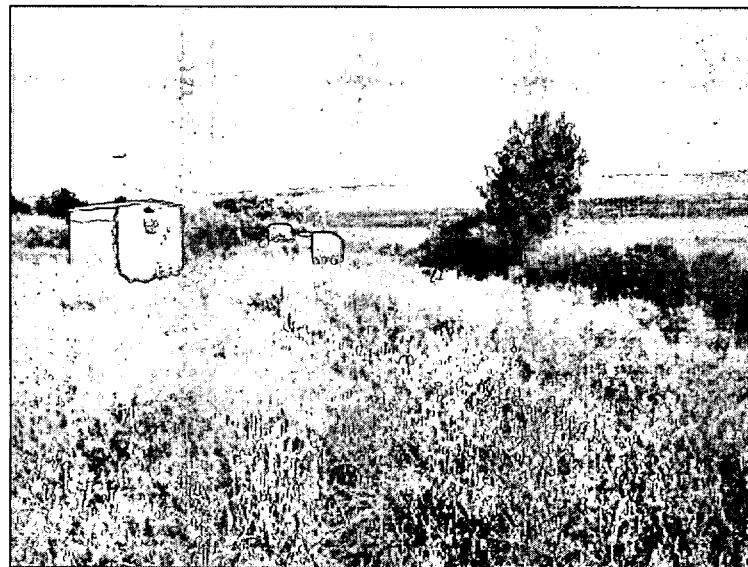
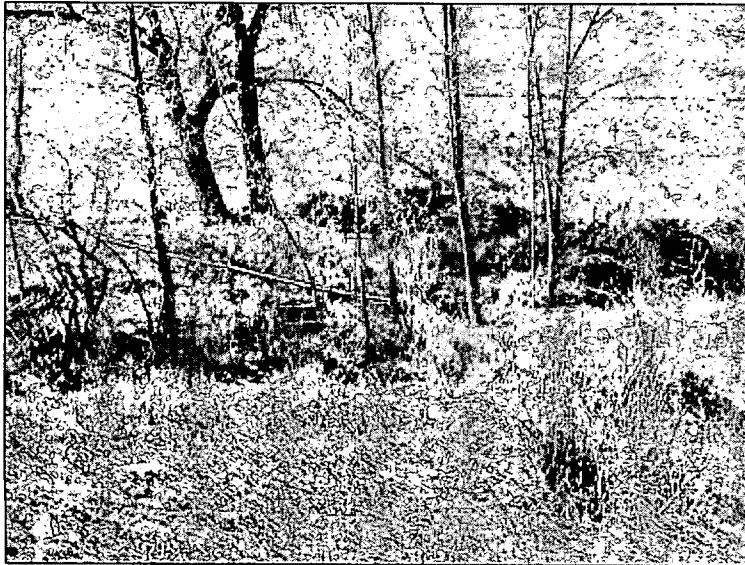
Figure 5. Comparison of pre- and post-construction vegetation conditions at SW093.

Post-construction Summer 2004

Pre-construction Winter 2002/2003

Post-construction Summer 2003

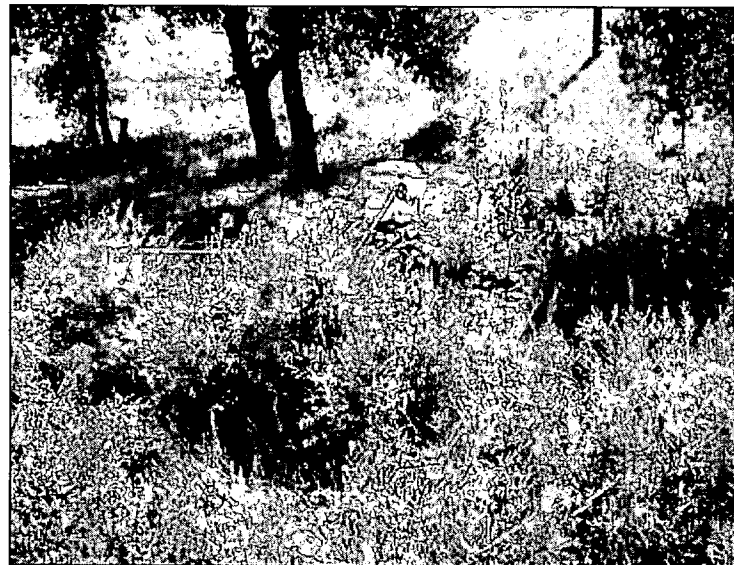
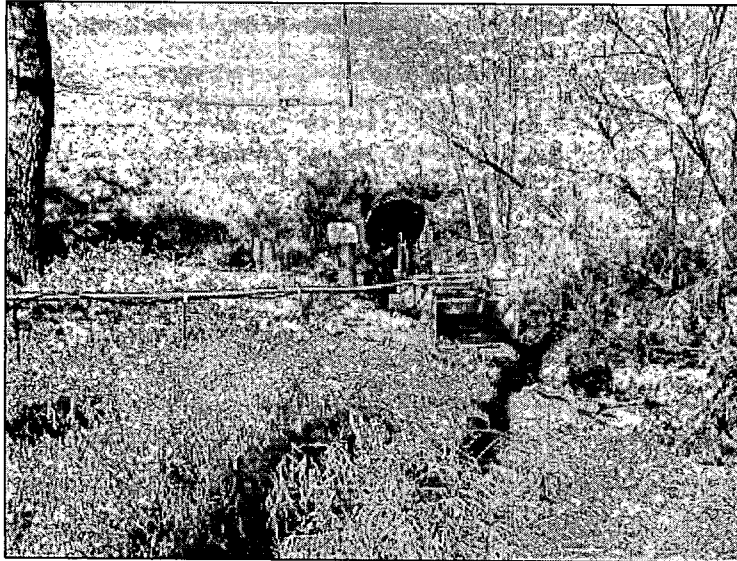
Figure 6. Comparison of pre- and post-construction vegetation conditions at SW093.

Post-construction Summer 2004

Pre-construction Winter 2001/2002

Pre-construction Summer 2002

Post-construction Summer 2003

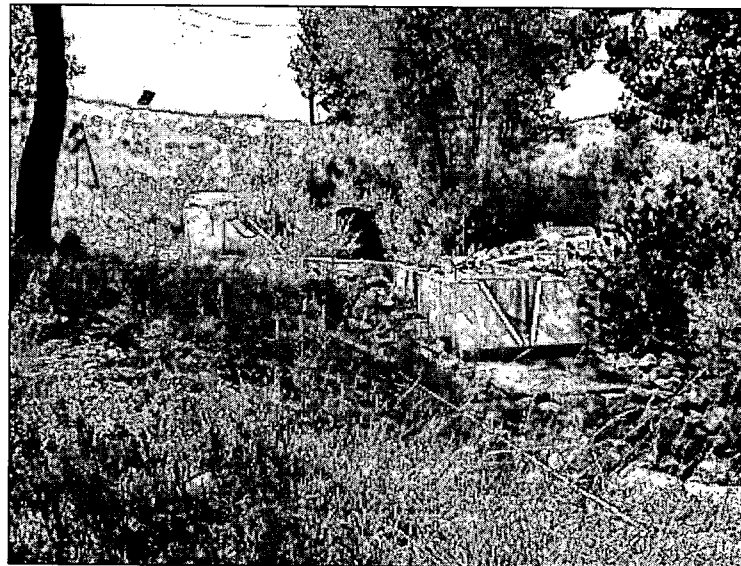
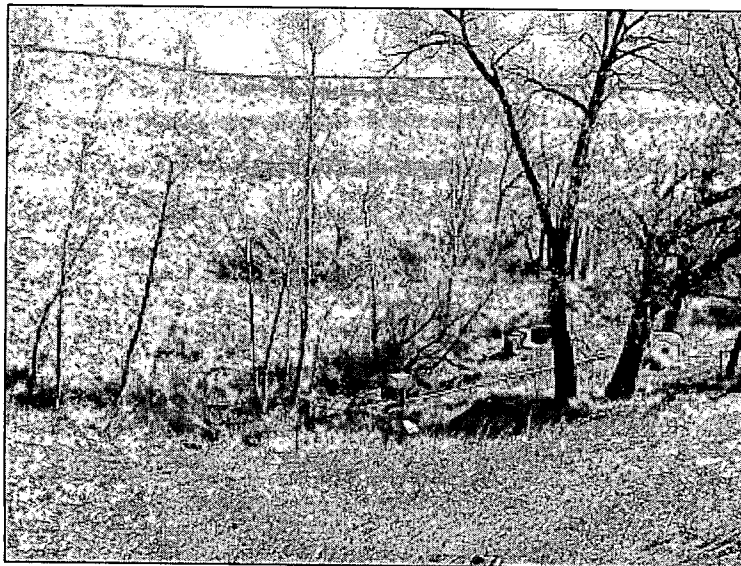
Figure 7. Comparison of pre- and post-construction vegetation conditions at SW093.

Post-construction Summer 2004

Pre-construction Winter 2001/2002

Pre-construction Summer 2002

Post-construction Summer 2003

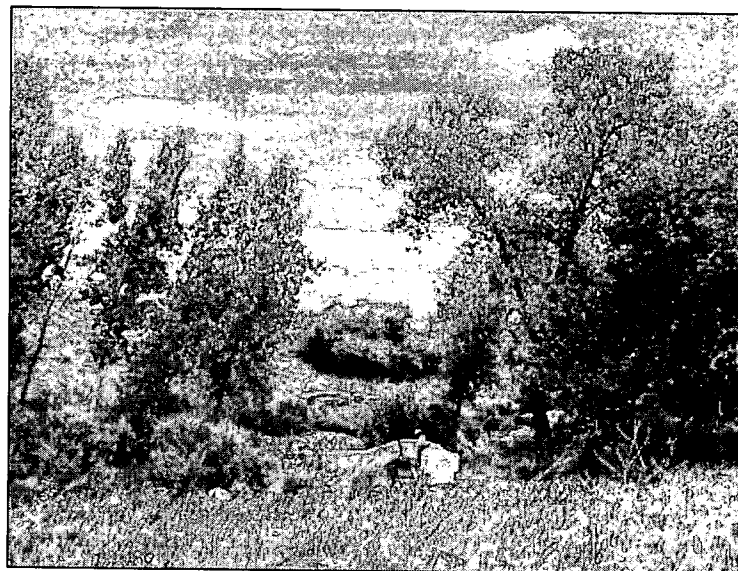
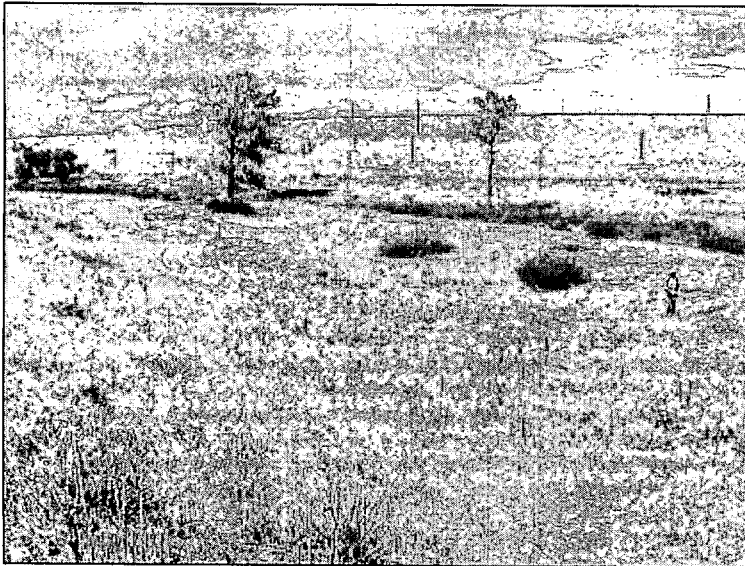
Figure 8. Comparison of pre- and post-planting conditions at the Enhancement Area.

Post-construction Summer 2004

Pre-planting Spring 2003

Post-planting Summer 2003

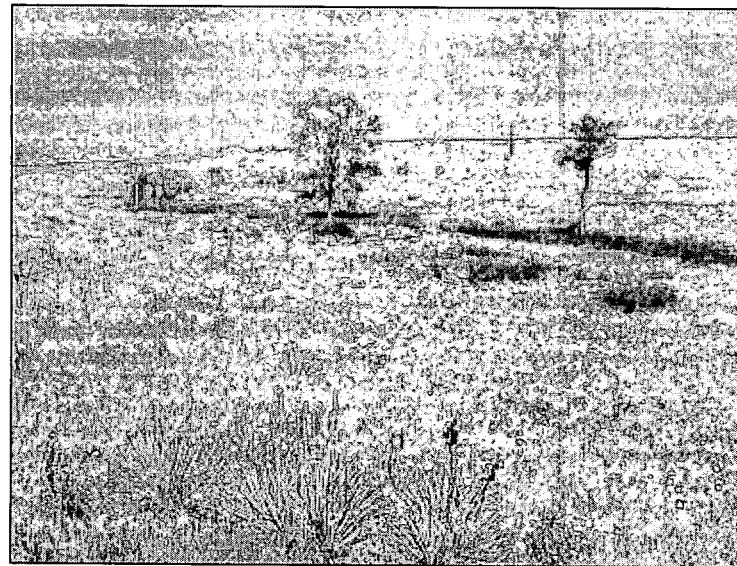
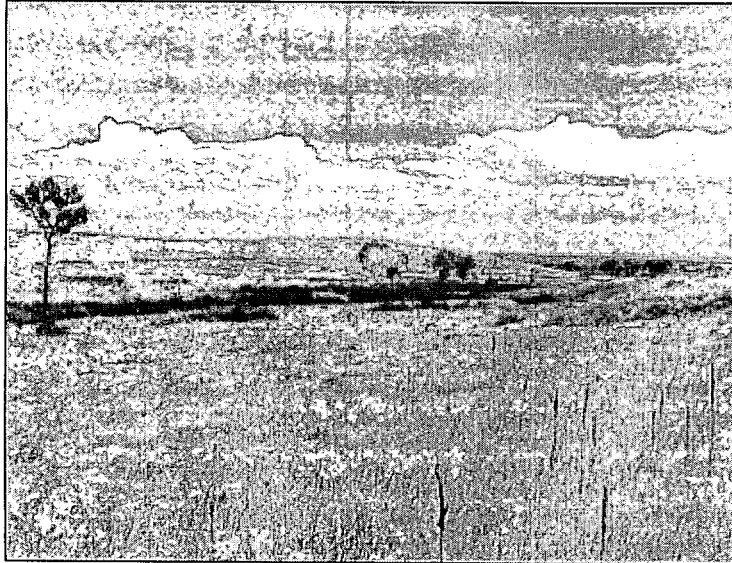
Figure 9. Comparison of pre- and post-planting conditions at the Enhancement Area.

Post-planting Summer 2004

Pre-planting Spring 2003

Post-planting Summer 2003
